**FORD:**

2004-2008 F-150

2006-2008 Mark LT

Some 2004-2008 F-150 and 2006-2008 Mark LT vehicles (excluding F-150 Heritage) may exhibit a vibration, felt in the floorpan and/or steering wheel when driven at highway speeds

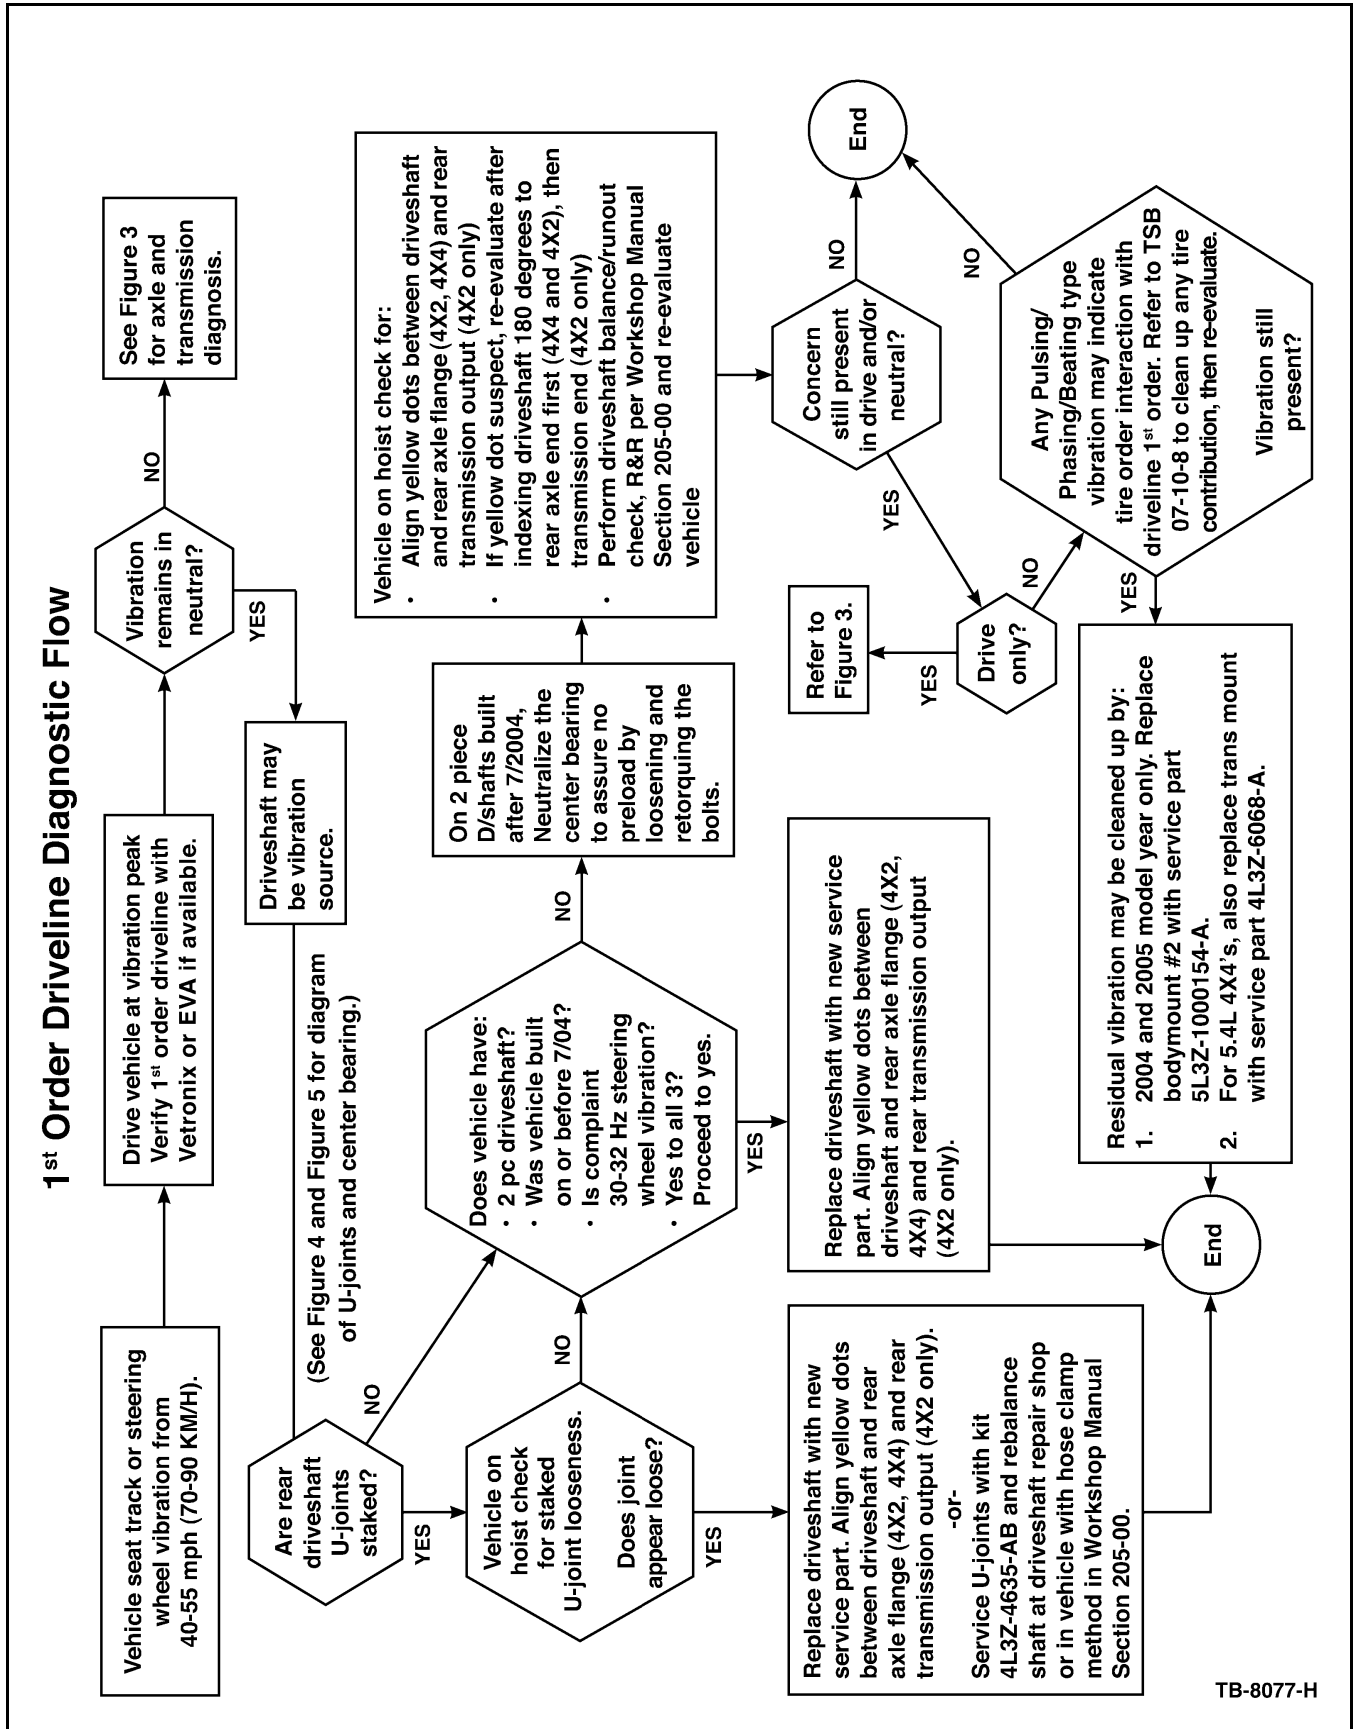
Figure 1 - Article 07-10-9

<b>DIAGNOSTIC OVERVIEW</b>			
<b>CUSTOMER CONCERN AND VEHICLE SPEED</b>	<b>OPERATING CONDITION AND EVA/VETRONIX READING</b>	<b>PROBABLE CAUSE</b>	<b>REPAIR ACTION(S)</b>
VEHICLE AND/OR STEERING WHEEL VIBRATION.  40-55 MPH (70-90 KM/H)	DURING ALL CONDITIONS: ACCEL/DECEL, COAST/ NEUTRAL, 4 <sup>TH</sup> OR 3 <sup>RD</sup> GEAR (O/D OFF).  NON-TORQUE SENSITIVE.  1 <sup>ST</sup> ORDER DRIVELINE (25-35 HZ)	DRIVELINE IMBALANCE DUE TO: 1. DRIVESHAFT RUNOUT 2. DRIVESHAFT IMBALANCE 3. U-JOINT DAMAGED (CUPS LOOSE OR PUSHED OUT) 4. NON-SYMMETRIC CENTER BEARING MOUNT (2-PC D/S ONLY)	FOLLOW 1 <sup>ST</sup> ORDER DRIVELINE VIBRATION DIAGNOSTIC FLOW CHART (FIGURES 2 AND 3)
	ACCEL OR DECEL TORQUE SENSITIVE. 1 <sup>ST</sup> ORDER DRIVELINE (25-35 HZ)	HIGH REAR AXLE GEAR SET PITCH LINE RUNOUT (PLRO)	FOLLOW 1 <sup>ST</sup> ORDER DRIVELINE VIBRATION DIAGNOSTIC FLOW CHART FIGURES 2 AND 3
VEHICLE AND/OR STEERING WHEEL VIBRATION.  50-65 MPH (80-105 KM/H)	DURING ALL CONDITIONS: ACCEL/DECEL, COAST/ NEUTRAL, 4 <sup>TH</sup> OR 3 <sup>RD</sup> GEAR (O/D OFF).  NON-TORQUE SENSITIVE.  1 <sup>ST</sup> ORDER TIRE (9-11 HZ)	TIRE-INDUCED VIBRATION INPUTS DUE TO IMBALANCE AND/OR ROAD FORCE.  NOTE: TIRE AND DRIVELINE VIBRATION MAY FEEL SIMILAR.	REFER TO TSB ARTICLE 07-10-8

SMOOTH ROAD-INDUCED VIBRATION (VARIES DEPENDING ON SURFACE).  NOT ORDER DEPENDENT (9-11 HZ).	VEHICLE SENSITIVITY AT 10 HZ RELATED TO VEHICLE TORSION MODE.	REFER TO TSB ARTICLE 07-10-8
	4 <sup>TH</sup> GEAR W/ TORQUE CONVERTER LOCKED AND ABSENT WHEN UNLOCKED.  1 <sup>ST</sup> ORDER DRIVELINE (35-45 HZ)	TRANSMISSION IMBALANCE AND/OR RUNOUT.	FOLLOW 1 <sup>ST</sup> ORDER DRIVELINE VIBRATION DIAGNOSTIC FLOW CHART (FIGURES 2 AND 3)
STEERING WHEEL NIBBLE/SHIMMY.  65-75 MPH (105-120 KM/H)	DURING ALL CONDITIONS ON SMOOTH ROADS.  1 <sup>ST</sup> ORDER TIRE (12-14 HZ)	1. TIRE/WHEEL IMBALANCE AND/OR ROAD FORCE. 2. OLDER STEERING GEAR.	REFER TO TSB ARTICLE 07-10-8
TAKE-OFF SHUTTER OR HIGH SPEED COAST DOWN VIBRATION	ACCELERATING FROM A STOP (10-25 MPH (16-40 KM/H)) OR COASTDOWN (ABOVE 75 MPH (120 KM/H))	DRIVELINE ANGLES	ADJUST REAR AXLE PINION ANGLE - REFER TO TSB 06-19-16

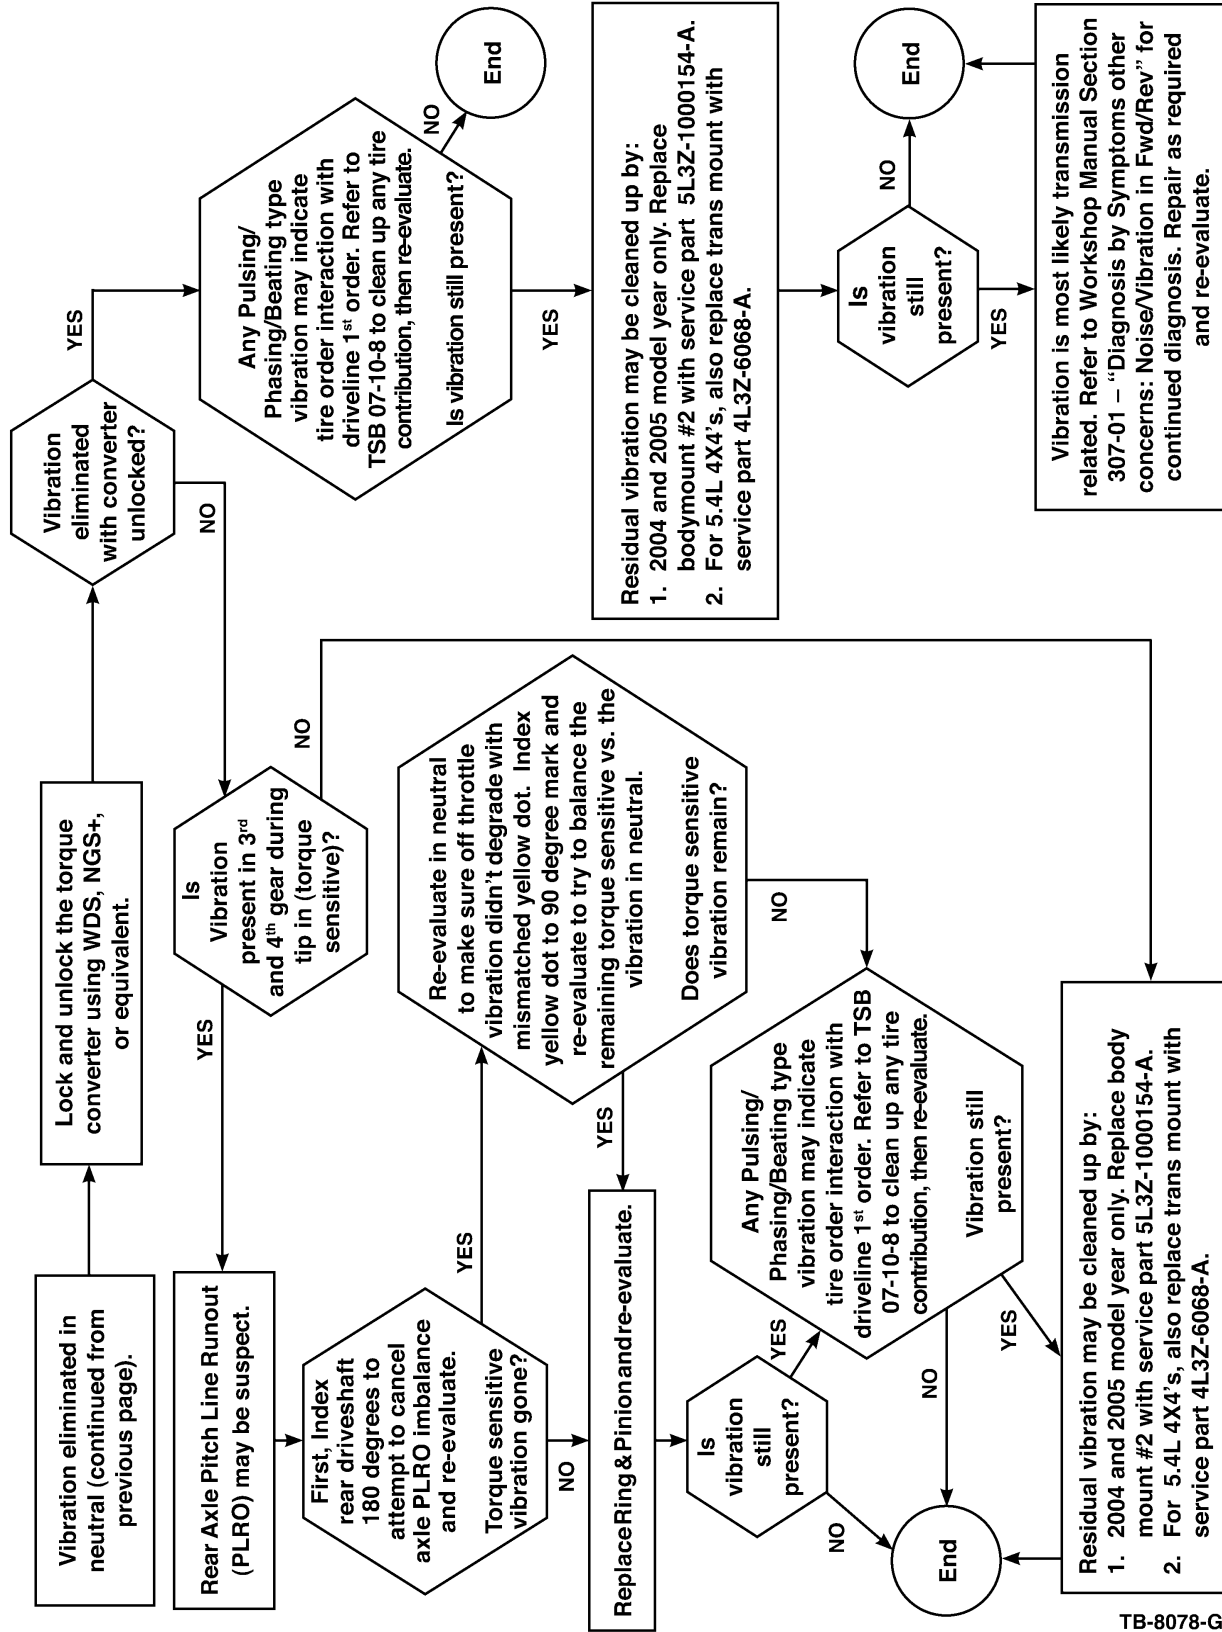
Figure 2 - Article 07-10-9

# 1<sup>st</sup> Order Driveline Diagnostic Flow
