**2009–10 TSX: Front Grille Lower Molding Peels, Wrinkles, or Blisters**

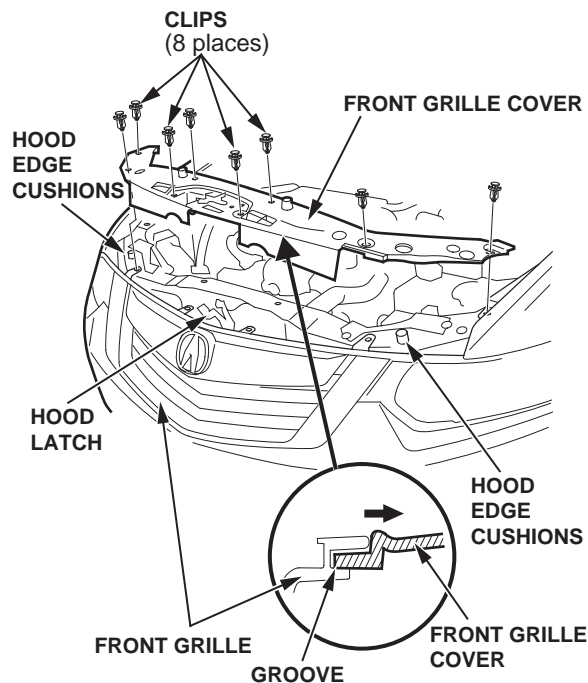
1. Remove the front grille cover:
  - Detach the clips.
  - Pull the rear edge of the cover over the hood edge cushions, then slide the entire cover rearward to release it from the groove in the front grille.
  - Lift the cover over the hood latch handle through the hole in the cover.

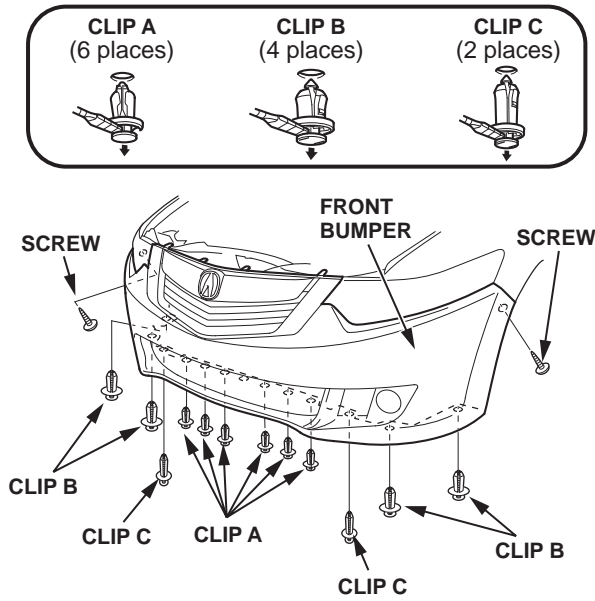
- Remove the front bumper by removing the screws and detaching the clips.

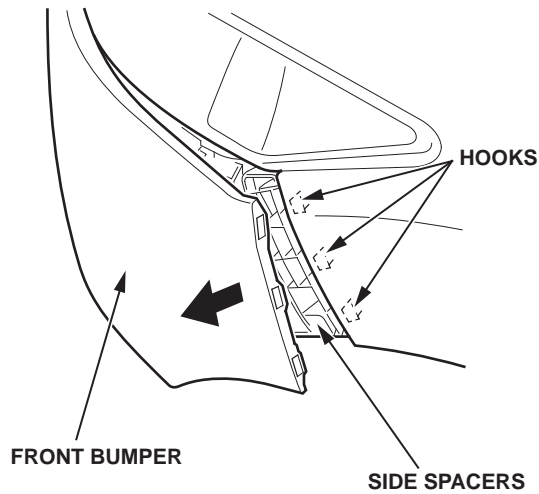
- Pull on the bumper at both wheel arch areas to release it from the hooks on the side spacers.

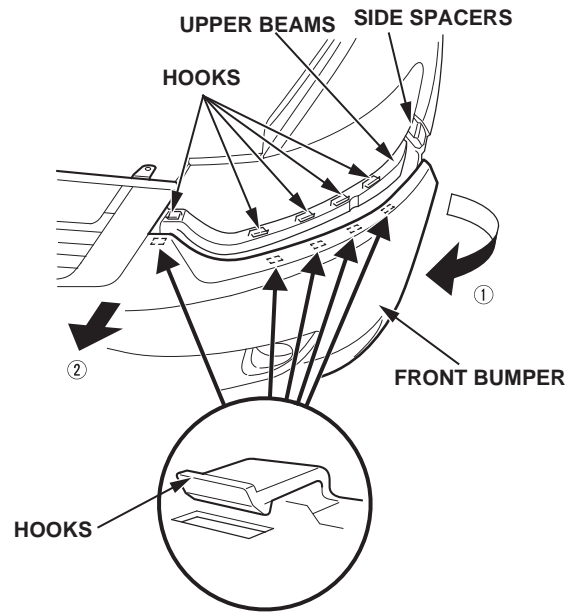
- With the help of an assistant, pull the bumper out to release the hooks from the upper beams.

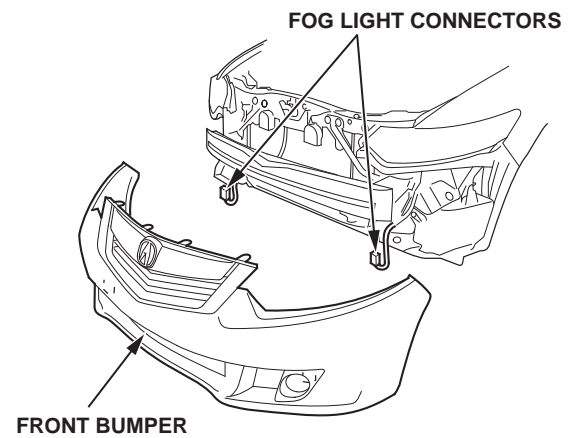
- With the help of an assistant, disconnect the fog light connectors while holding the bumper, then remove the bumper.

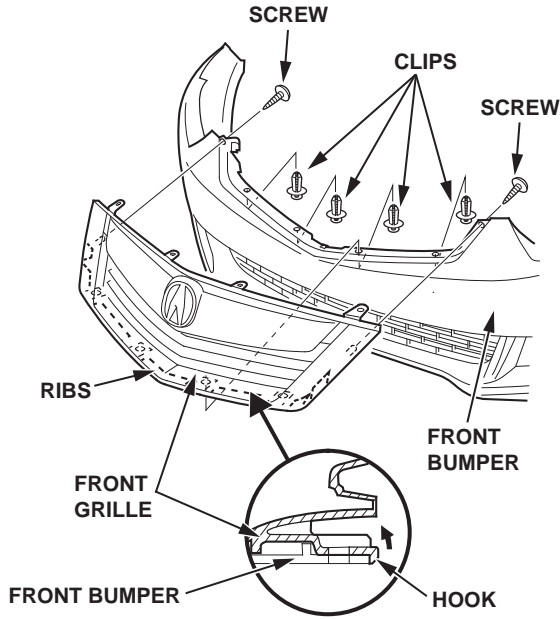
- Remove the grille by removing the screws, detaching the clips, and releasing the hooks and ribs from the bumper.

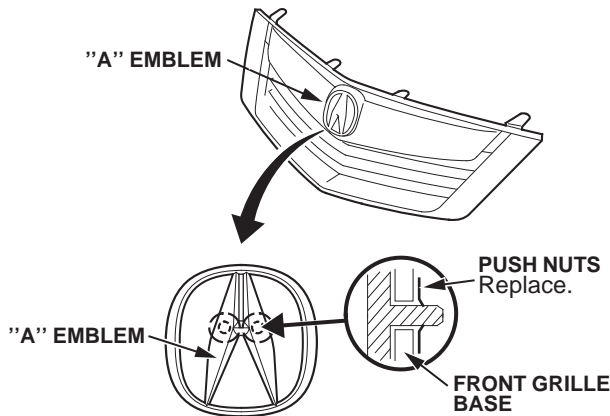
- Remove the "A" emblem from the front grille molding.

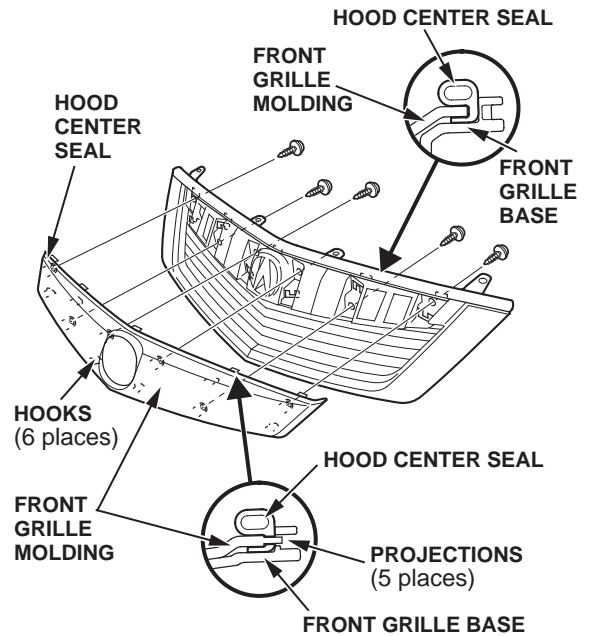
- Remove the front grille molding by removing the screws, releasing the hooks (six places) from the grille base, and releasing the projections (five places) from the hood center seal.

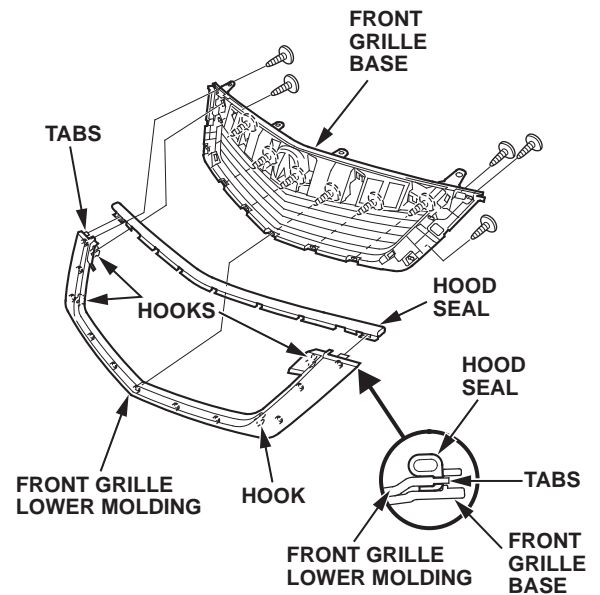
- Remove the screws. Pull out the front grille lower molding to release the hooks from the front grille base. Detach the tabs holding the hood seal, then remove the front grille lower molding.

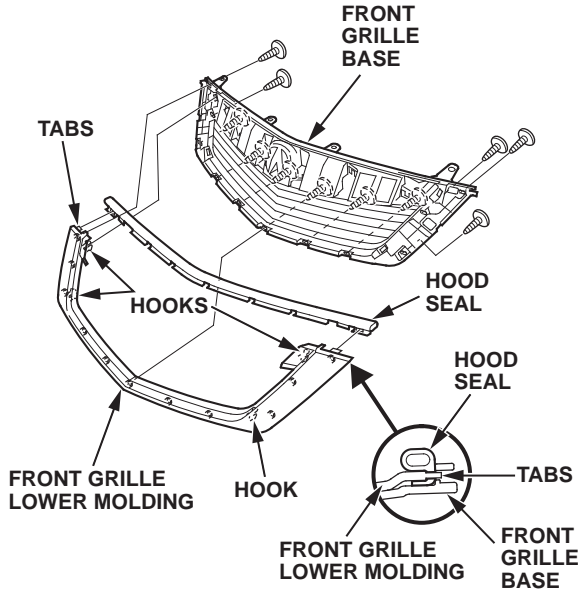
10. Reattach the tabs holding the hood seal, then install the new front grille lower molding with the original screws.

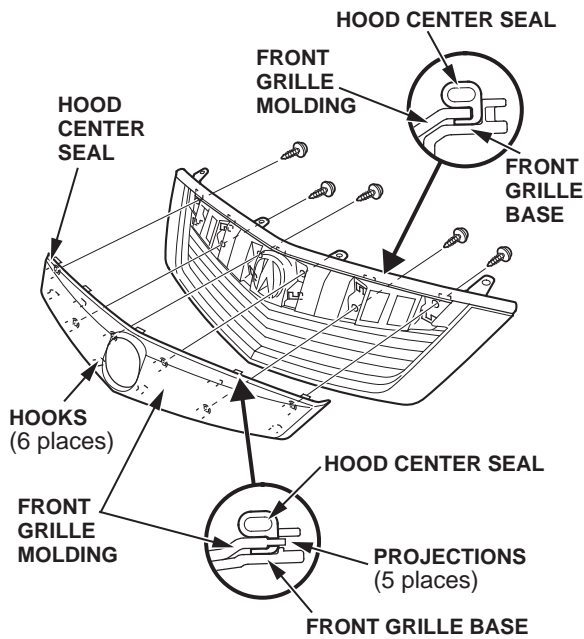
11. Install the front grille molding.

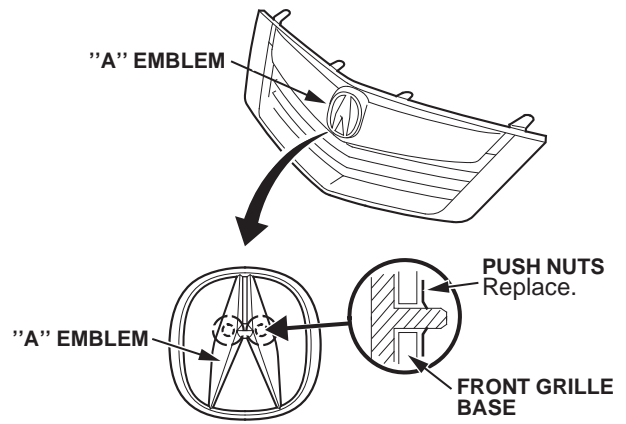
12. Attach the new "A" emblem using new push nuts.

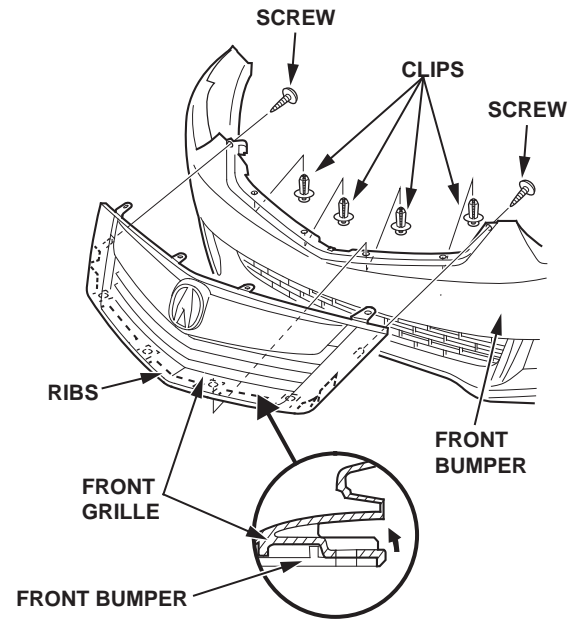
13. Reattach the grille to the bumper.

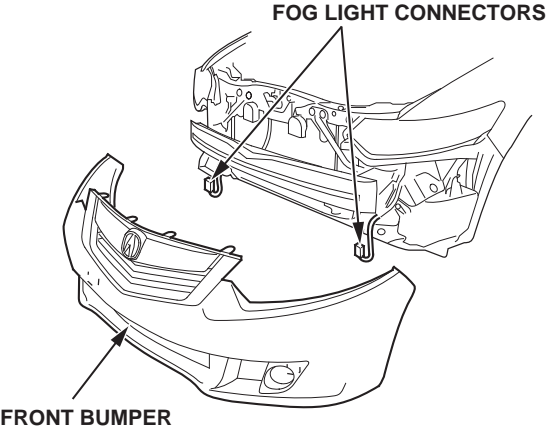
14. With the help of an assistant, reconnect the fog light connectors, and reattach the bumper to the vehicle. Make sure the bumper securely engages the hooks on both the upper beam and the side spacers securely on each side.

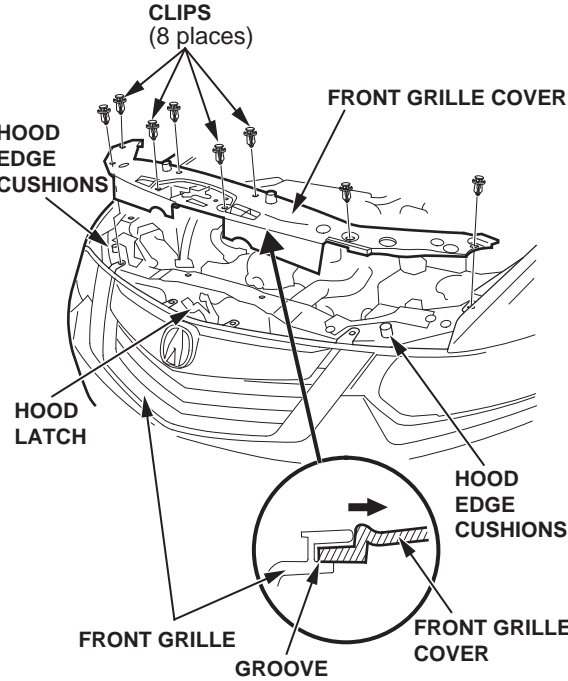
15. Reinstall the front grille cover over the hood edge cushions and the hood latch handle. Reinstall the clips.
